## Numerical study of the strengthening techniques of Mornos aqueduct - a case study

Vassilios J. Soulis<sup>†</sup> & Randa Hattab<sup>‡</sup>

**ABSTRACT:** In March 2011, a failure of Mornos aqueduct in the Athens Water Supply occurred in Central Greece. In the present study, a series of numerical investigations are performed in an effort to find out and propose different strengthening techniques that will raise the horizontal bearing capacity of the aqueduct under study. This study is particularly useful for reducing failures of the aqueduct system in the future and to propose an evaluation tool of the structural performance of relative structures. The external water supply system of Athens includes 189 km of aqueducts, tunnels and siphons that transfer water from the rich rainfall in Western Greece to the city of Athens. The R/C canal aqueduct is formed from articulated segments that are joined together using an interlocking system that adopts protrusions and intrusions in their joint interfaces. This system has suffered the most significant failures along the 40 years of its operation. This methodological approach of the evaluation of the numerical behaviour of the canal, in

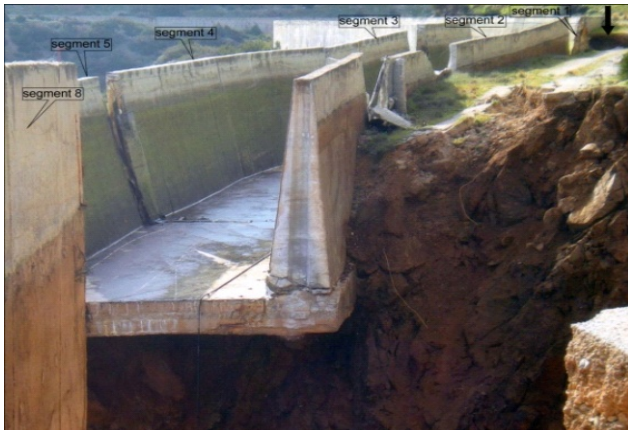
Mourtzas et al studied the causes of the recent failure at Taxiarches canal that was activated in March 2011 [2]. Their study was based on geological mapping, evaluation of the engineering geological conditions, soil fracture characteristics, the damage to the canal segments and their measured displacements. The study by Mourtzas et al (2013) also included findings that originated from the geotechnical borehole drilling, inclinometers installation and geophysical survey. These findings were retrieved in the current study for evaluation of the numerical behaviour of the aqueduct's simulation. The failure of the canal occurred after intense snow fall, in an area of steep morphology, at the front of an overthrust, within material of reduced mechanical properties, vulnerable to erosion. The soil fracture of the canal foundation caused detachments between segments, outflow of great water quantities and damage to the downstream village of Saranti.

Figure 1: Soil subsidence uphill of the left canal wall between segments 1 and 2 [2].

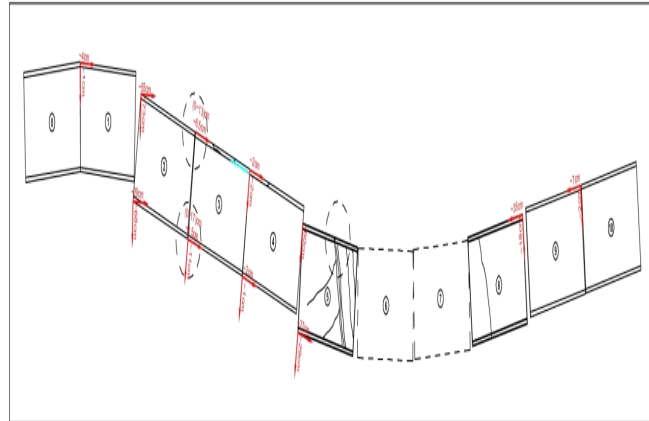
Figure 2: Displacement vectors of canal segments [2].

The methodology adopted for the investigation of the failure mechanism that was developed numerically predicts deformation patterns that are greater in the area of the maximised curvature of the aqueduct's length under study. This finding agrees with the deformation pattern of the failed aqueduct as shown in Figure 2.

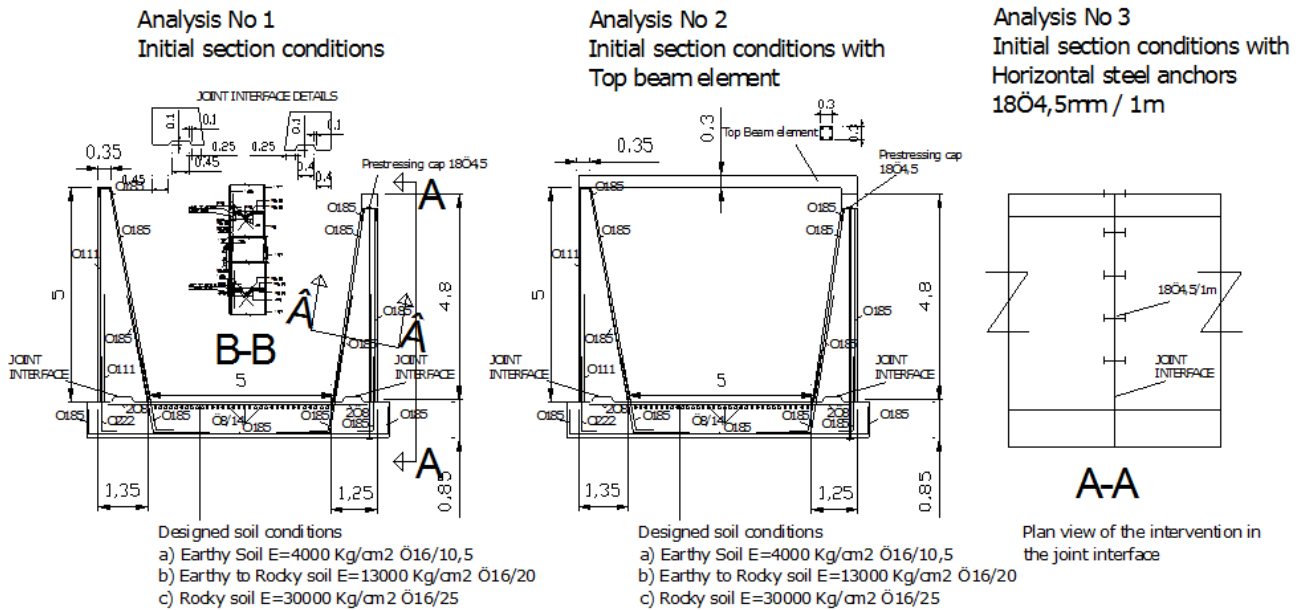
The canal segments, walls and the bed plates were constructed from reinforced concrete. The vertical walls were designed as gravity walls with trapezoidal shape. The left wall in respect to the water flow was higher than the right wall. The reason for this design difference is related to the backfill soil conditions of the surveillance road that the left wall was designed to retain. On the contrary, the right wall was adjacent to the steep soil of the original excavation with slope inclination higher than 2:3 (h: b). Later, the right wall was strengthened by the application of pre-stressed steel wires (18Φ4.5/80 cm). The typical geometry of a canal section in the area of failure is shown in Figure 3. The reinforcement details are also shown in Figure 3. In Table 1, the *as built* material properties of the construction materials are listed.

Figure 3: Typical reinforcement details of the canal section in the area of failure \*distances cm.

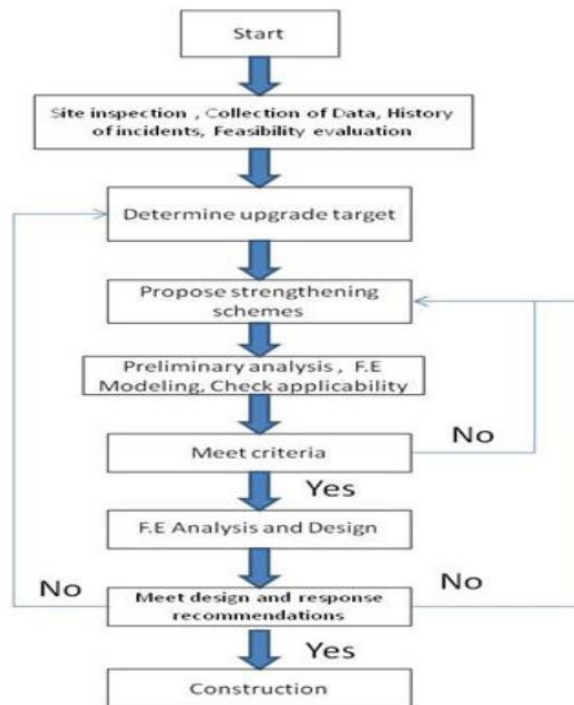
Figure 4: Strengthening evaluation algorithm.

In Figure 4, a strengthening evaluation algorithm is proposed for aqueduct structures. This algorithm was applied in the current investigation. The two strengthening schemes (Analysis No 2 and No 3) are evaluated in respect to the failure pattern ( $x$  sign) and the non-linear mechanism of the joint interface that is developed in respect to the failure pattern predicted by the actual structural scheme that originally failed (Analysis No 1). The comparison between the failure patterns predicted by the three analyses is shown in Figures 5a, 6a and 7a. The distribution of these failures is most extended in Figures 5a and 5c. The same inspection is carried out for the axial elongation of the interface in Figures 5b, 6b and 7b. Finally, the tensile and compressive in-plane stresses in the walls of the aqueduct for the three analyses can be depicted in Figures 5c, 6c and 7c. The vertical displacements that were approximated numerically were of magnitude of 2.6 mm. Table 6 shows the results of the three analyses.

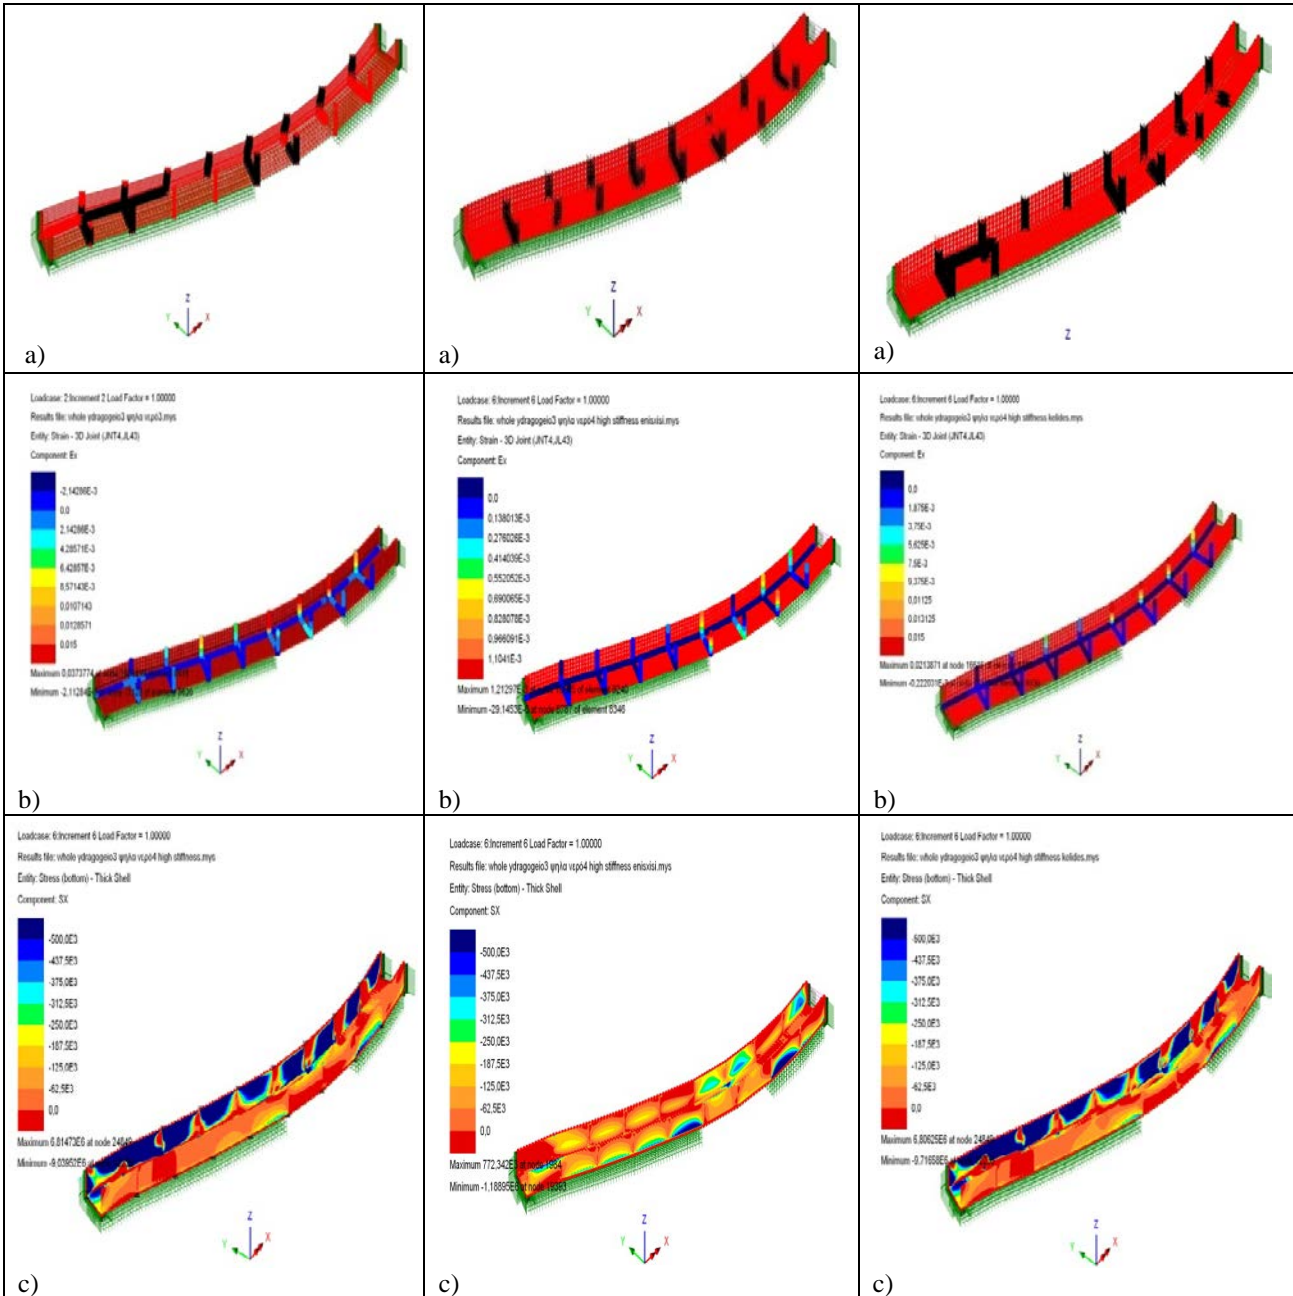
The measured displacement pattern of the failed aqueduct sections has occurred after the original displacement and during the soil erosion that followed the outflow of water from the detached joints. The numerical analysis could not identify the rigid body motion of the aqueduct after failure and after the soil erosion of the foundations of the aqueduct. In Table 6, the numerical predicted patterns of displacements are presented for the three different analyses carried out. The results from analyses No 1 and No 3 have shown much greater displacements in comparison with Analysis No 2.

The load combination that predicts the highest magnitudes of displacement is associated with high water table and, therefore, high hydrostatic pressures acting on the exterior wall of the canal are due to the saturated soil conditions. All the non-linear mechanisms were developed in the interface joints between successive segments. This is an additional reason that suggests that failure was a consequence of detachment of joints that was soon followed by leakage of water that caused the vertical displacement (sinking) of the subsoil next to the canal segments in the right hillside of the canal. In that sense, the failure mechanism was predicted successfully by the numerical simulation.

Figure 5: Analysis No 1: a) failure of the joint interfaces; b) axial strain along the joint interfaces; c) in-plane stress contours along wall (bottom layer).

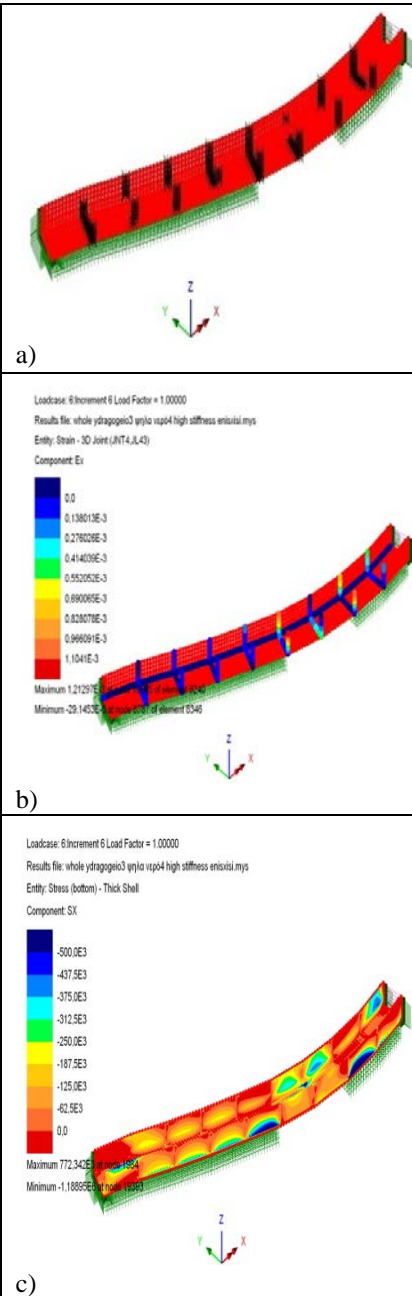
Figure 6: Analysis No 2: a) failure of the joint interfaces; b) axial strain along the joint interfaces; c) in-plane stress contours along wall (bottom layer).

The placement of beam elements that join the sides of the aqueduct as assumed in Analysis No 2, led to reduced failures in the joint between segments, reduced strain elongation in the same joints and lower in-plane tensile stresses at the aqueduct's walls in comparison with the predictions of Analysis No 1 and Analysis No 3. The placement of steel horizontal anchors at the joint between vertical joints (Analysis No 3) although they have beneficial impact in respect to the overall performance, when it is compared with the behaviour predicted by Analysis No 1, they also predict openings, strain elongations in the joint interfaces and tensile stresses in the walls of the aqueduct (Figures 4, 5 and 6). In such way, unfavourable openings in the joints between segments are predicted.

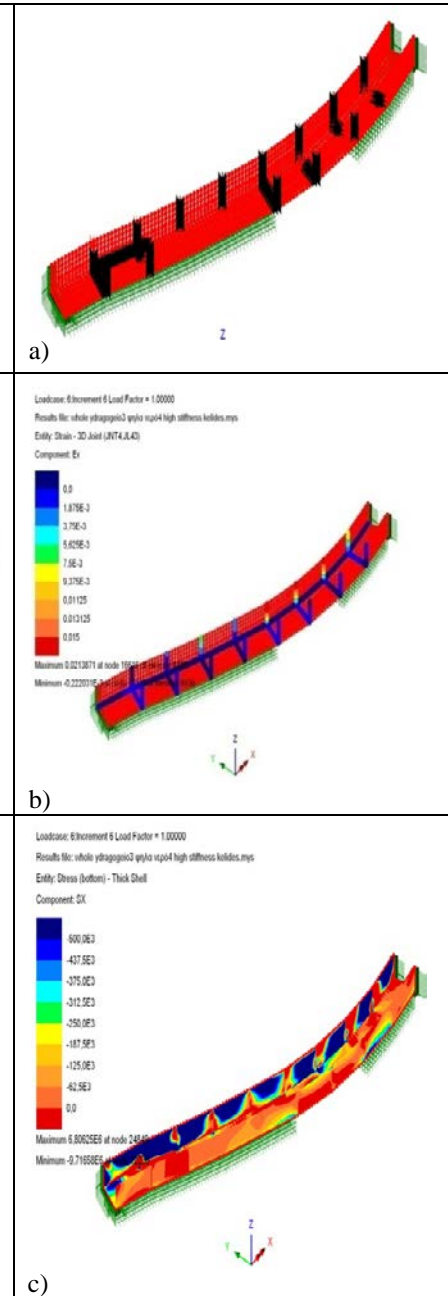
Figure 7: Analysis No 3: a) failure of the joint interfaces; b) axial strain along the joint interfaces; c) in-plane stress contours along wall (bottom layer).
