The importance of site investigation in the construction industry: a lesson to be taught to every graduate civil and structural engineer

Nicholas Hytiris, Robert Stott & Kenneth McInnes

Glasgow Caledonian University
Glasgow, Scotland, United Kingdom

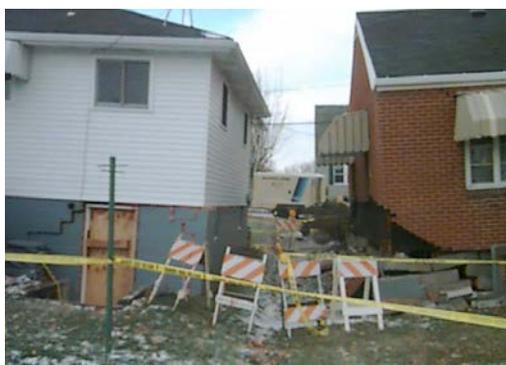
Figure 1: Collapsed foundations and associated cracked mortar within brick and block work of residential structures as a result of unforeseen ground conditions.

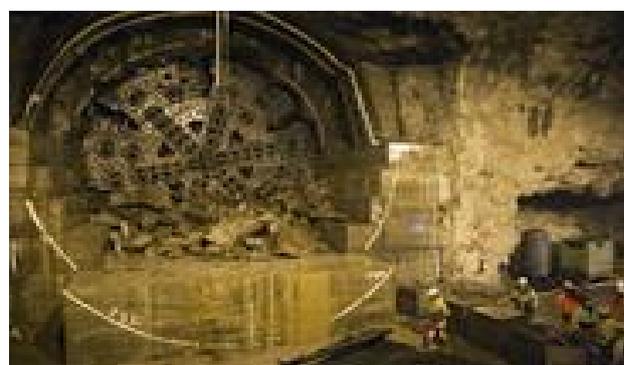
Figure 2: Flooded section of the tunnel due to a lack of geotechnical expertise.

The Hallandsås tunnel project in Sweden involved the construction of two 8.6 km long railway tunnels through rock which were designed to increase the capacity of Sweden's west coast railway. Initial costs, however, escalated from the original budget of £440 million to £840 million at 2008 prices as a result of flawed construction processes based on poor geotechnical expertise [7]. Construction of the tunnel began in 1992 through the Hallandsås Ridge, which is a bedrock horst that was formed millions of years ago. Although the most common types of rock, gneiss and amphibolites, with granite and diabase found in smaller quantities were of excellent quality, sections of the ridge were exceptionally cracked and severely disintegrated containing large volumes of water.

A Swedish contractor, Kraftbyggarna, commenced the project but left with only 3 km completed when its open tunnel boring machine proved unable to deal with the disintegrated rock in 1995. Skanska took over as the contractor in 1996, and in an attempt to make up for lost time, opened an audit in the centre of the ridge. However, this only resulted in further large volumes of water leaking into the northern tunnel. A chemical sealant, Rhoca Gil, was discontinued in 1997 after it was discovered that it had run into the streams, which the tunnel water released into contaminating them with acrylamide. As a consequence, the tunnel construction was brought to a halt with just one third completed.

In 2004, work recommenced following a seven year hiatus to seal the tunnels with a waterproof lining. The revised, bored method performed satisfactorily, but progress was slower than had been anticipated, primarily due to unforeseen ground and water conditions. As at April 2009, progress was measured at 59% complete with rail traffic estimated to commence in 2015.

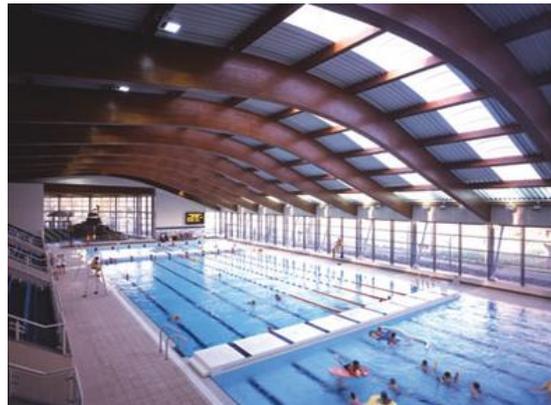
Figure 3: Catering for a mix of leisure, teaching and fitness swimming.

Generally, pools require depths ranging from 1 m to 1.2 m for leisure purposes and are required to be 2 m deep for swimming at a competitive level. Greater depths will consequently require a bigger tank, greater filtration and heating plant. A high water table in the site's ground conditions may require ground anchoring of the pool tank should water pressure become too high [13].
